Culvert pipe materials and durability: Making the right selection for Minnesota

**Craig Taylor & Jeff Marr
St. Anthony Falls Laboratory**

May 22, 2013

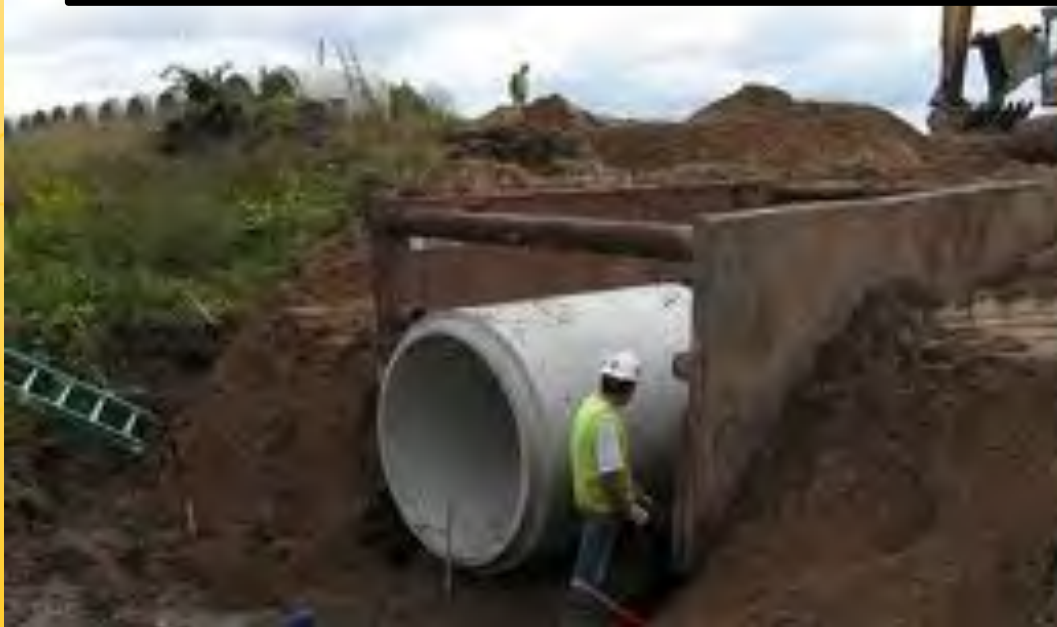
- **Reinforced Concrete Pipe**
 - Most common in the state. Durable pipe
 - Service life can exceed 100 years

!Tie bars are structural elements!

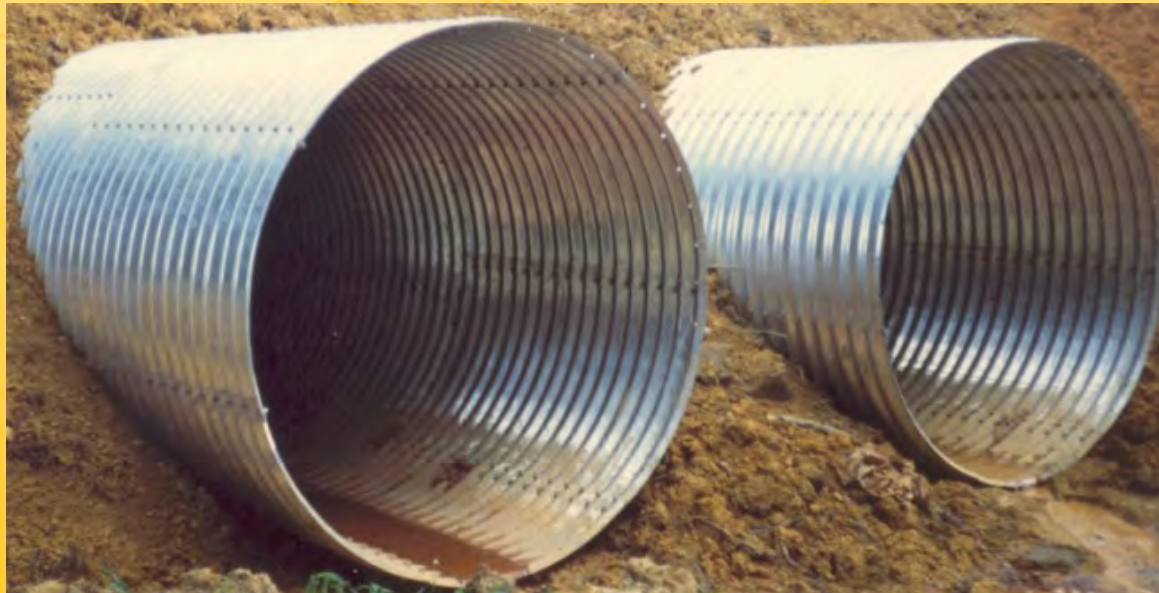
- **Galvanized Corrugated Metal Pipe**
 - Commonly used, inexpensive, lightweight, available
 - Design service life from 25-50 years.

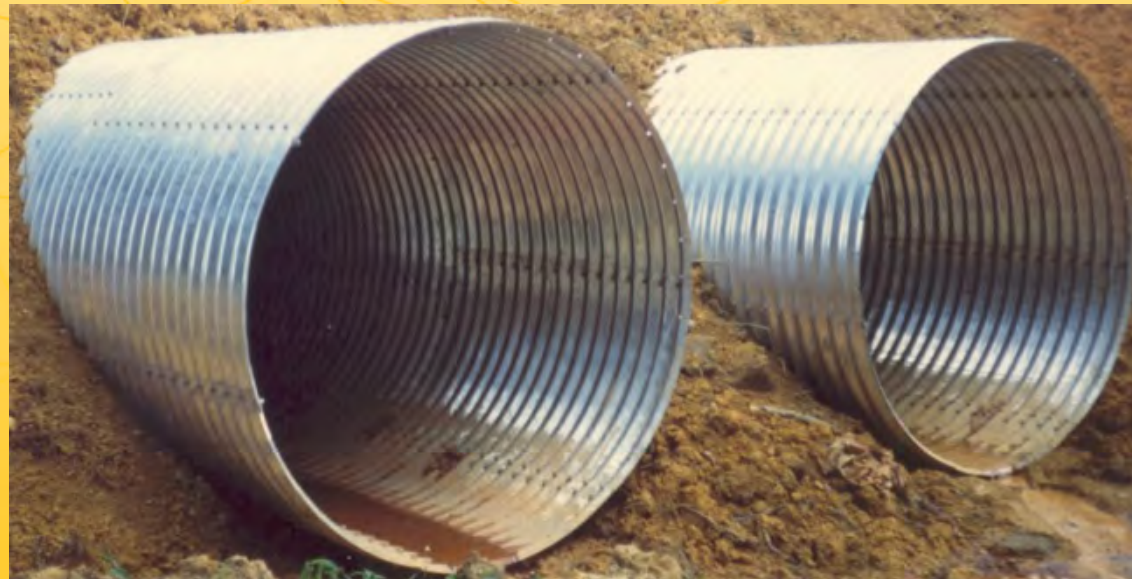
- **Aluminized Corrugated Metal Pipe**
 - Less-commonly used but positive feedback on use
 - Service life 3-8 times longer than galvanized

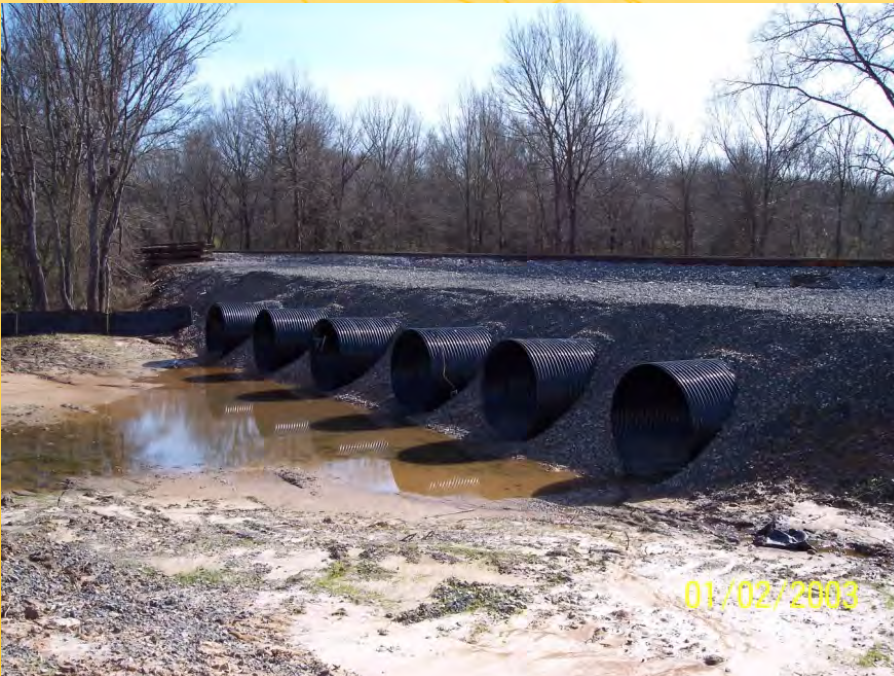
- **Polymeric coated corrugated metal pipe**
 - Less common, lightweight
 - Optimum service life 100 years
 - Extremely Difficult to install!

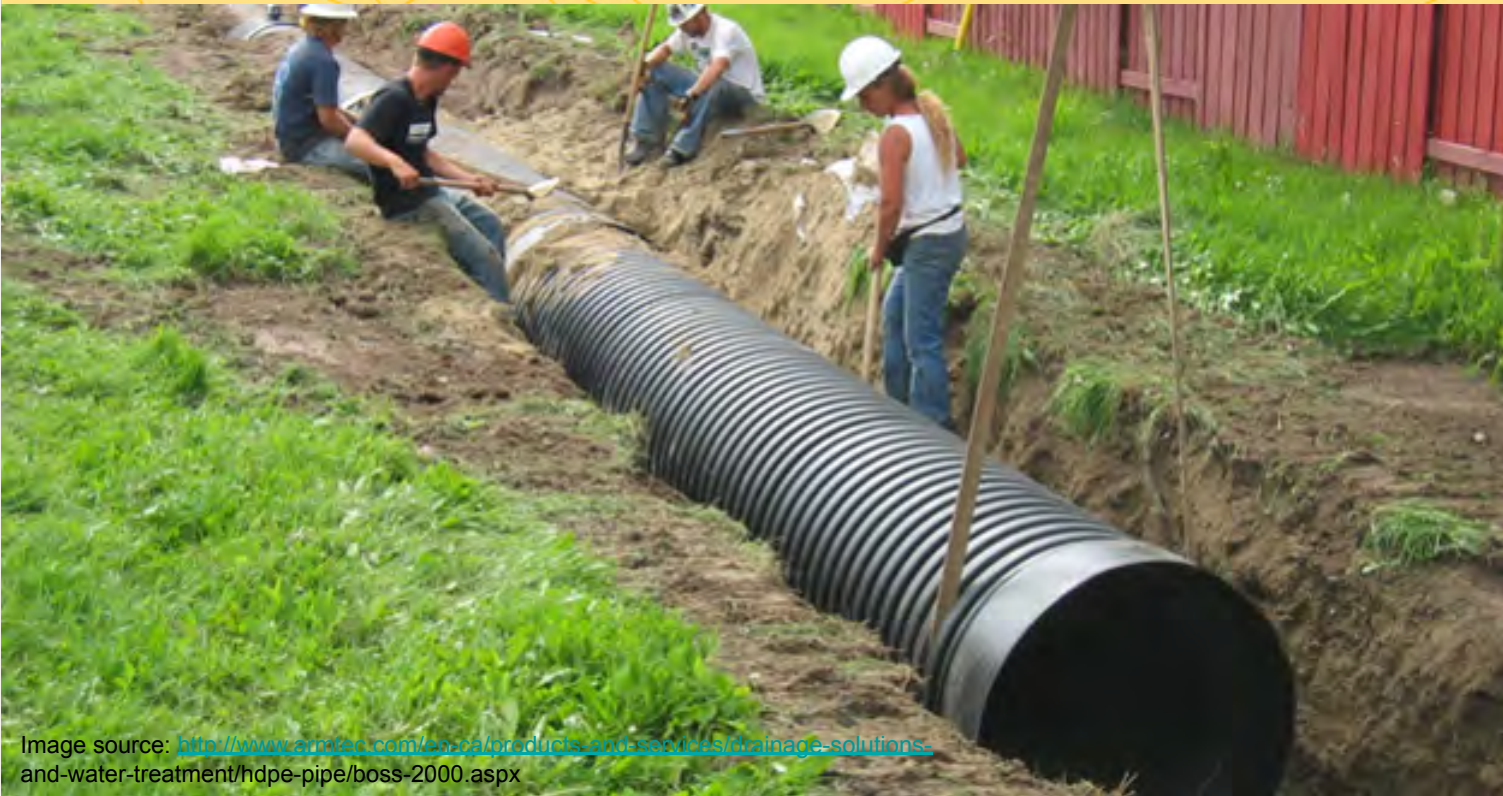
- **HDPE**
 - Lightweight
 - Good service life 50-100years

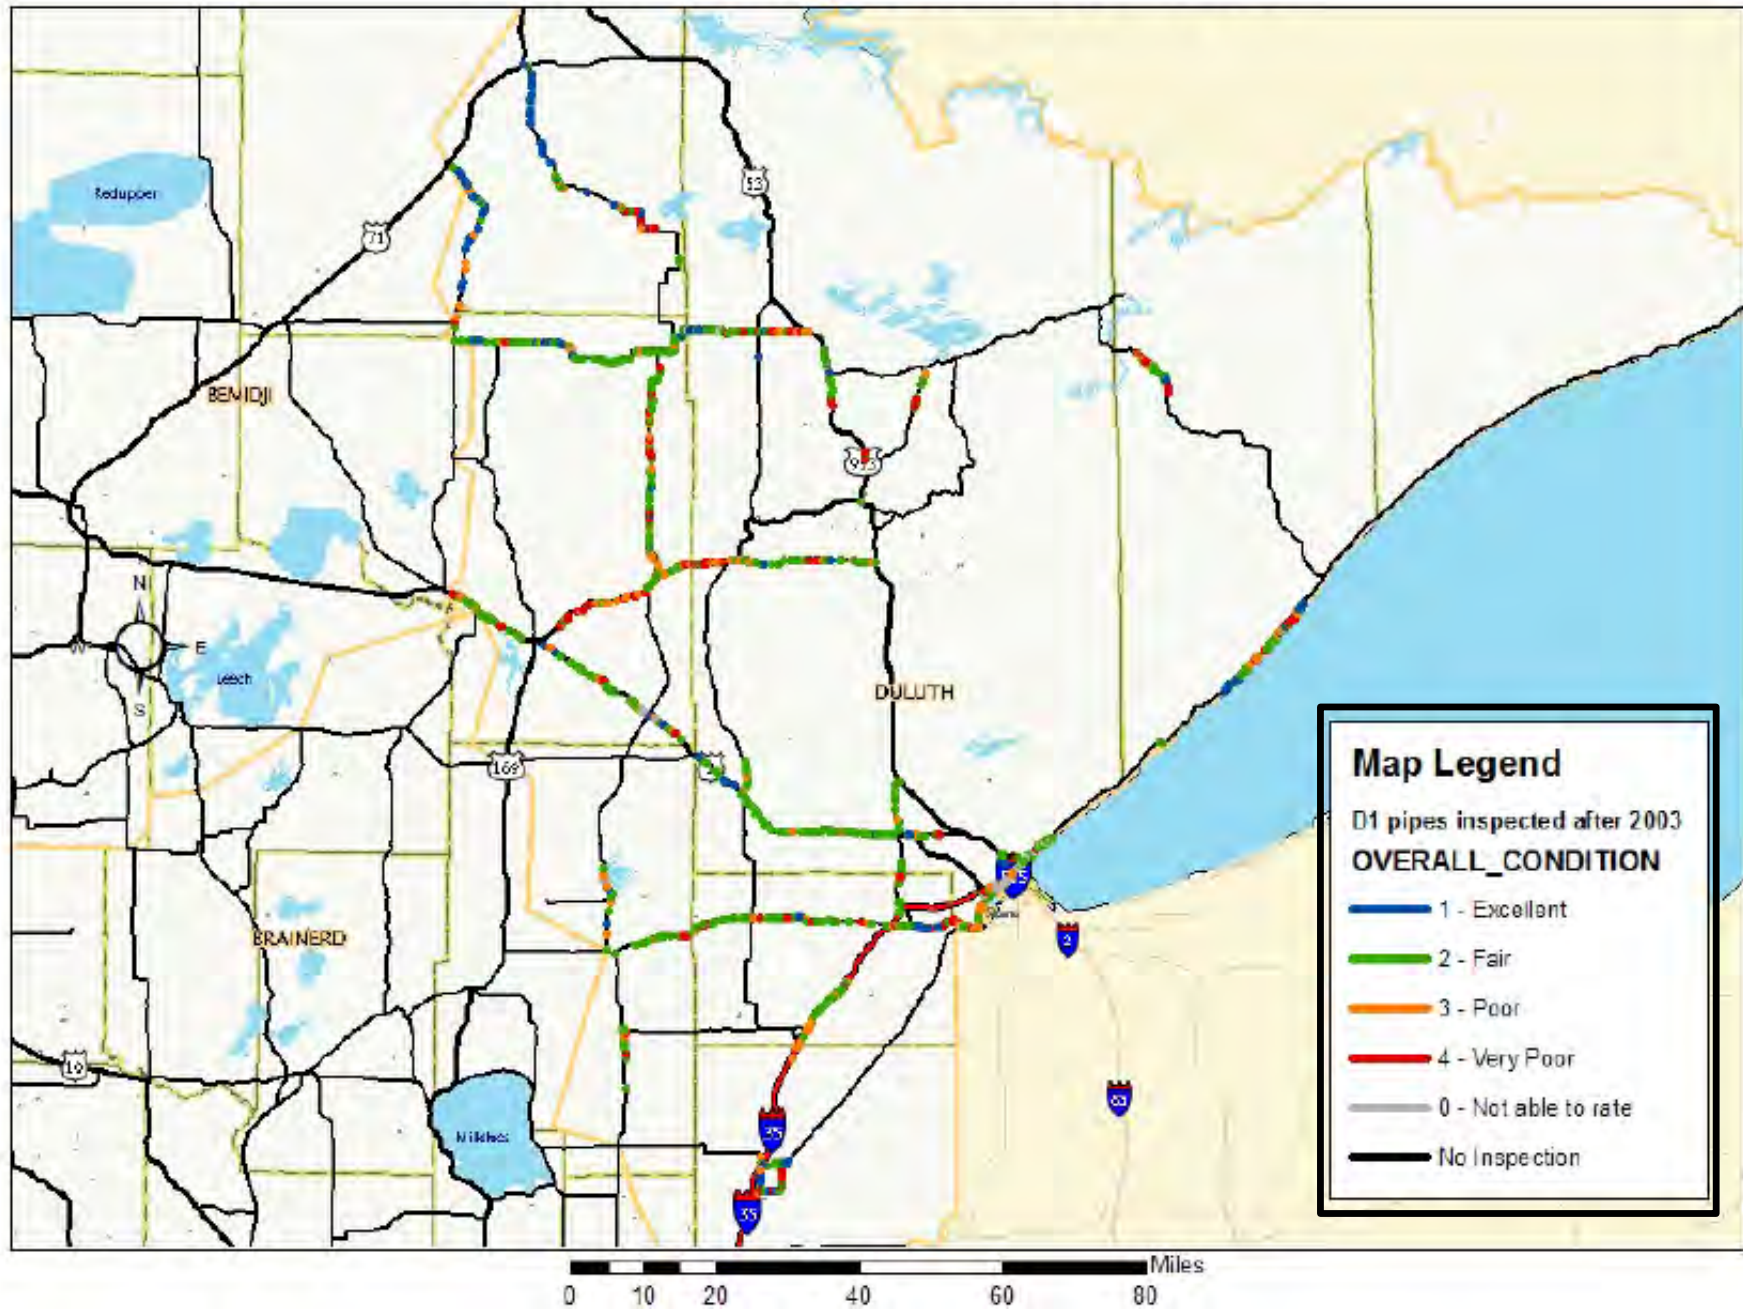
District 1 Pipe Conditions in HydInfra Inspections January 1, 2004 till April 1, 2008

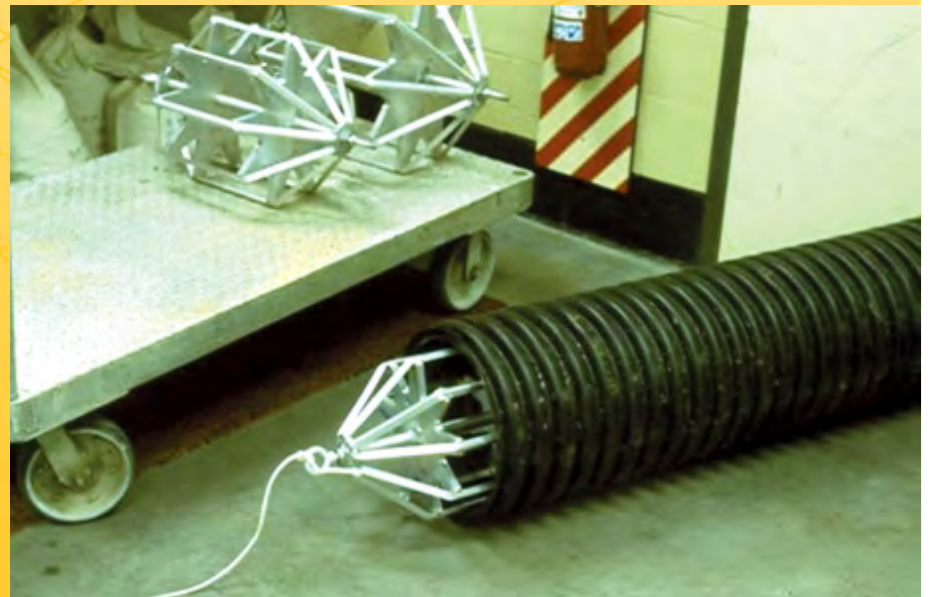
- Split HDPE pipe into two classes
 - Class I: 50-year material service life
 - Class II: 100-year material service life
- Adopt Florida DOT testing methods for determining HDPE material service life

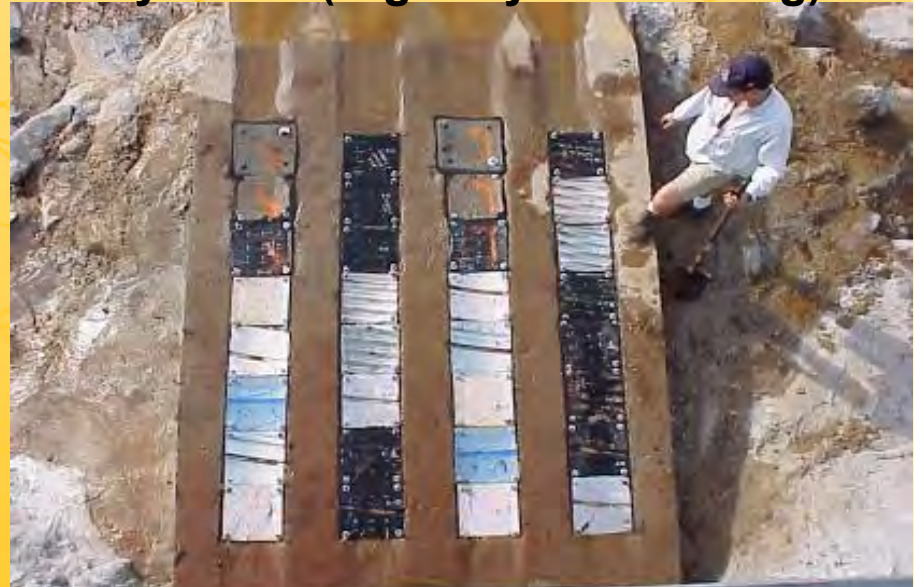
Shady Creek (Highway 49 crossing) CA

- Adopt CalTrans abrasive conditions design methods
 - Abrasive conditions determined by previous installation
 - Found in NCHRP Project Report 20-07
